- Technology Condition Survey Report
- 10-Year Comprehensive Technology Roadmap

March 13, 2024

*Prepared for Anytown Central School District,
Anytown, NY*

Presented by MasterLibrary Professional Services

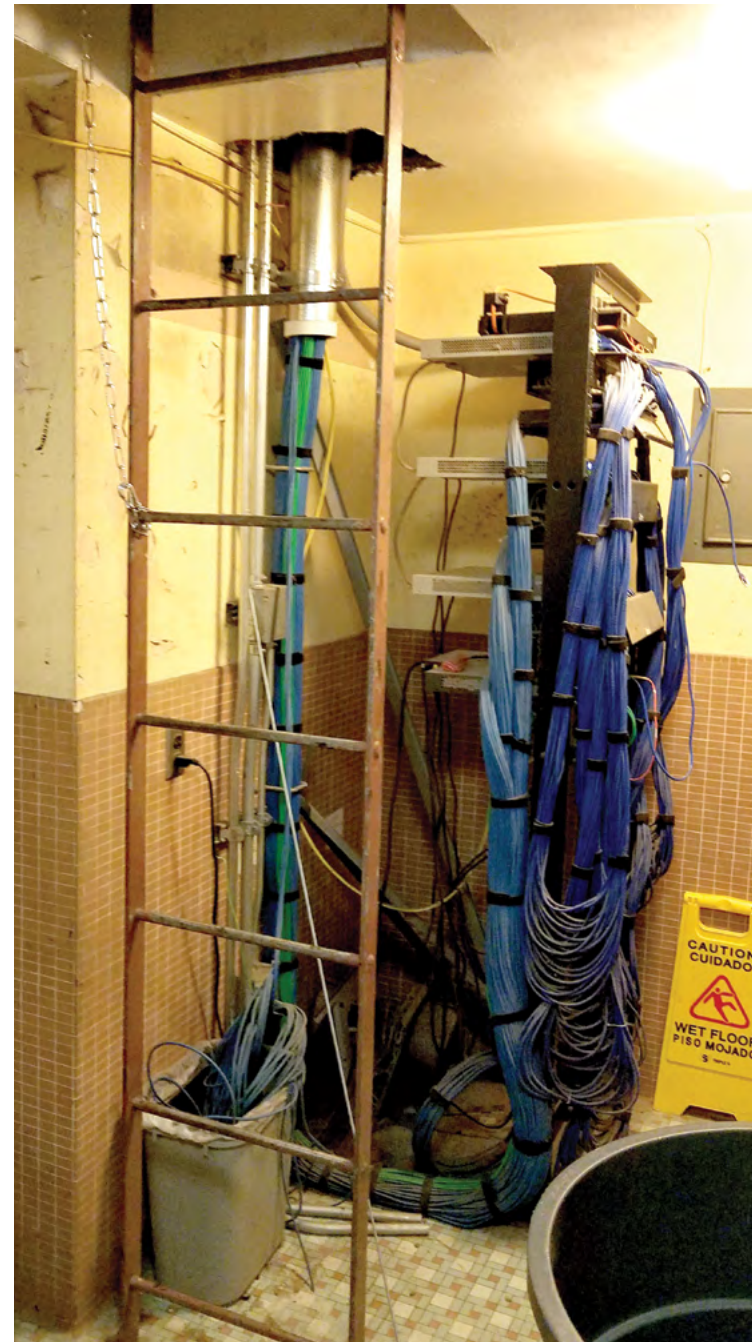
What makes a poor TR bad...

- 1 Room size and inadequate rack clearances** inhibit serviceability.
- 2 Overhead utility pipes** leave racks susceptible to damage from leaks/bursts.

- 3 Location** lacks direct hallway access and the Serving Zone distance is greater than 300'.
- 4 Unsecured, shared space** creates a life safety and security risk as well as causing possible accidental damage.

- 6 No dedicated and redundant power.** Both a dedicated circuit and a power outlet from a building generator are needed.
- 7 Lack of Uninterruptible Power Supply (UPS)** or emergency power source creates life safety risks during power outages, and reduces equipment lifespan due to a lack of conditioned power.

- 8 Lack of grounding infrastructure** increases risk of electrical shortage and equipment damage.
- 9 Overhead cable management** is lacking putting cables at risk of damage.

- 10 No cable management or correct termination at the rack** can cause operational issues and makes troubleshooting difficult.
- 11 Poor room construction** with no deck access and poor cable penetrations.

- 12 Floor tile** is not anti-static increasing risk of Electro-Static Discharge.
- 13 Hard ceiling** inhibits inspection and serviceability, and limits airflow while trapping heat.

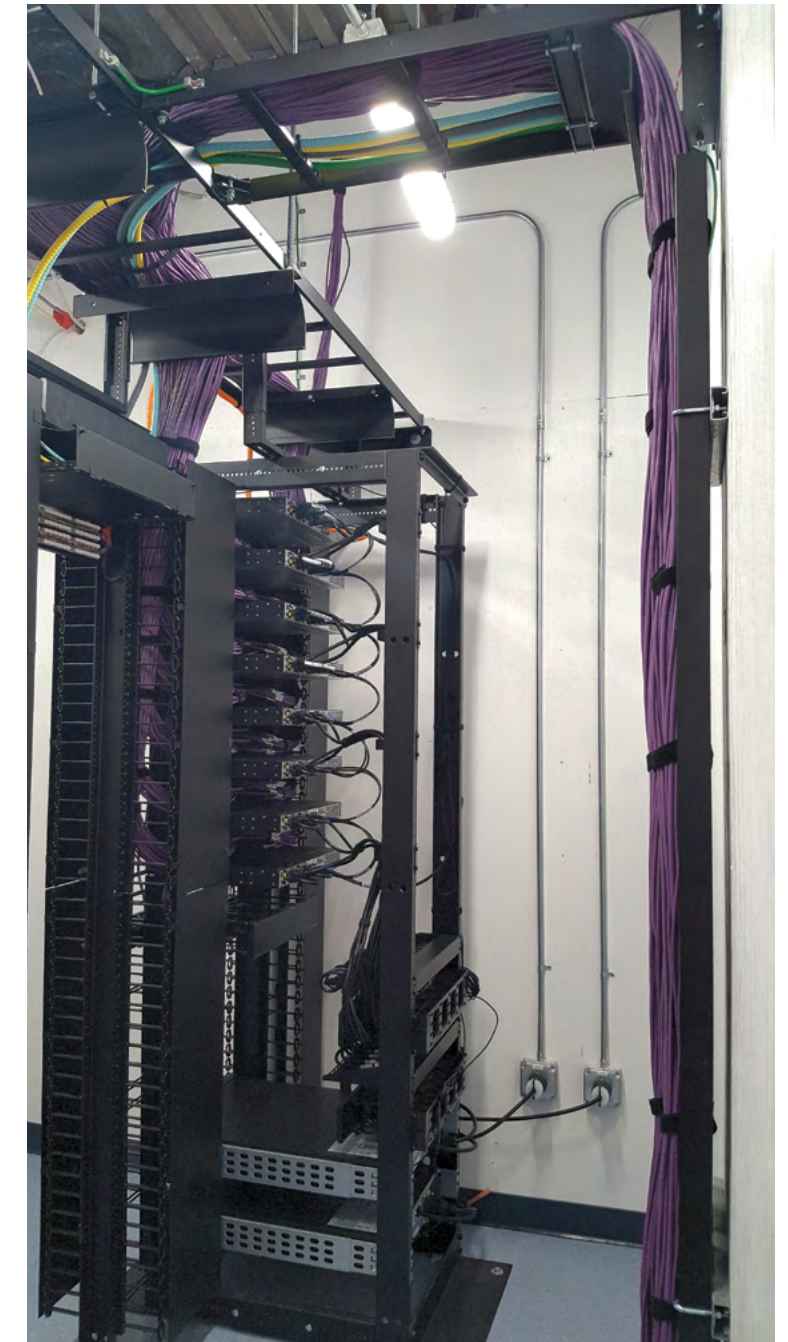
13-Point Checklist for IT Equipment Spaces

1. Size with 3' clear space front and back
2. No risks of water damage.
3. Environment/location/hallway access
4. Secure/dedicated space or locked cabinet
5. Environmental controls
6. Dedicated, redundant power
7. Uninterruptible Power Source (UPS)/ Emergency Management (EM) power
8. Grounding infrastructure
9. Overhead cable management and fire-retardant plywood
10. Cable termination and management at the rack
11. Room construction with walls extended to deck, and compliant, sealed cable penetrations
12. Vinyl-Coated Tile (VCT) flooring
13. Ceiling open to deck with minimum height of 10'

- 11 Room construction.** Walls extend to deck. Cable penetrations are compliant and sealed (fire stopped).
- 12 VCT flooring.** Anti-static tile bonded with copper strips

- 13 Ceiling.** Open to deck with 10' minimum height Above Finished Floor.

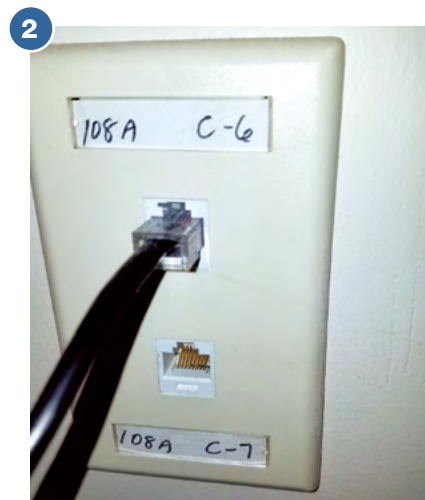
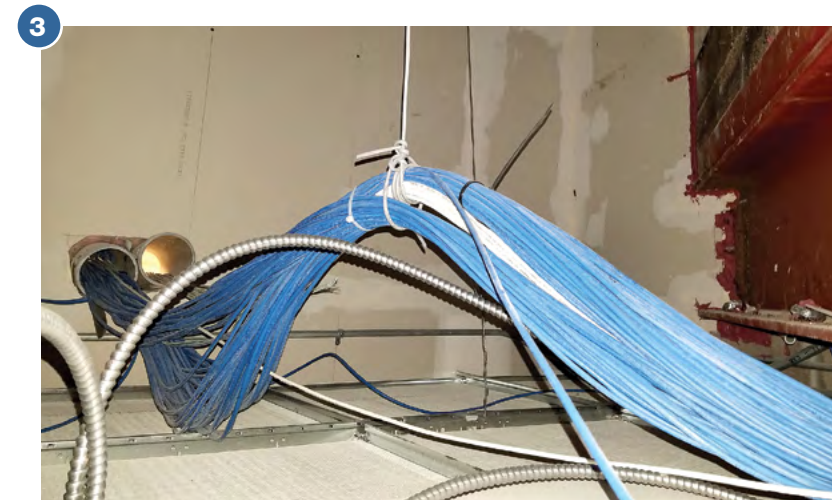
1. ES and MS non-compliant horizontal cable management.
2. Typical ES and MS cabling with non-compliant labeling.
3. Improperly supported horizontal cable in the High School.
4. Ladder racking correctly installed and deployed in the MTR - Server Room 154.

4	Cable Counts	Generally, cable counts are adequate for current District needs.	
	2	Cable Labeling	The district lacks cable labeling conventions resulting in inconsistent and inadequate cable labels throughout the district.	
	0	Serving Zones	Serving Zones for each floor are not documented.	
	4	Wireless Access Point (WAP) Cabling	(2) Cat6A cables are installed for each WAP.	
Backbone Cabling	4	Intra-building Fiber Optic Backbone (within a building)	50-micron Multi Mode (MM) and Single Mode (SM) fiber are installed throughout the building.	No recommendations at this time.
	N/A	Inter-building Fiber Optic Backbone (between buildings)	The district has a single Central School building with no inter-building connections.	
Communications Pathways	2	Cable Tray	Except for the Main Telecom Room (MTR), there is minimal use of cable tray throughout the District.	<ol style="list-style-type: none"> 1. Install new/add cable tray down all corridors and in other areas of the building. 2. Correctly install all existing and new cable into the tray.

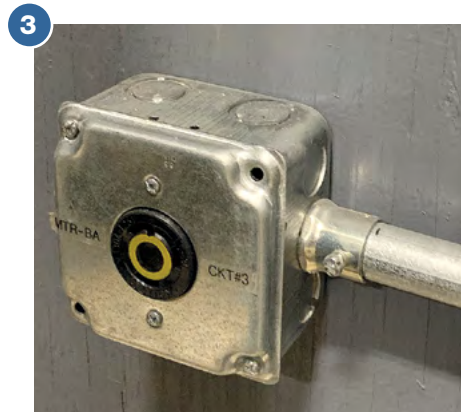
The space is in **good** condition and requires moderate upgrades to meet industry standards.

1. The dedicated secure space includes (3) newer equipment racks.
2. The racks include properly installed cable lengths and management.
3. A properly labeled electrical outlet from the building's emergency generator.
4. A properly installed grounding bar with all components correctly connected.

- Install video surveillance coverage of the door.
- Properly label all electrical outlets.
- Install treated plywood and firestop.

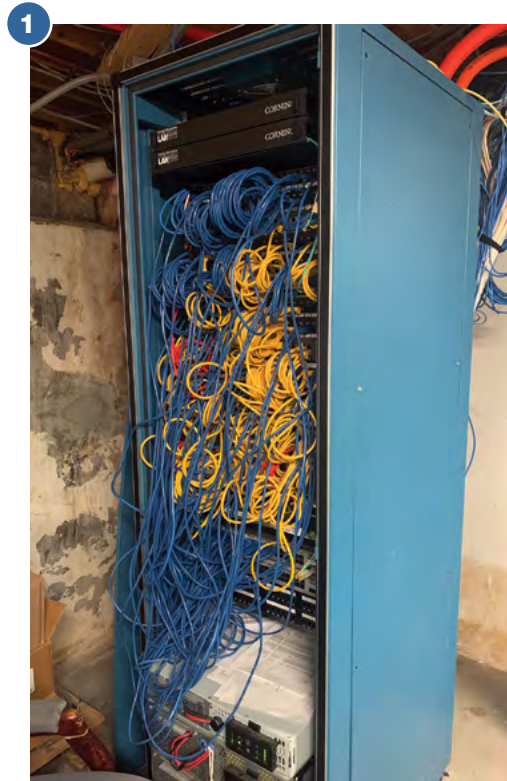
The space is in **poor** condition and is not worth the investment to upgrade it to industry standards.

Photos, clockwise from top left:
 1. The open rack is in an unsecured area that is shared with custodial items.
 2. The space is below grade, a water pipe is installed directly over the rack, and cable management systems are lacking.
 3. Conduits are filled beyond capacities.
 4. There is a janitorial slop sink in the same space as the equipment.

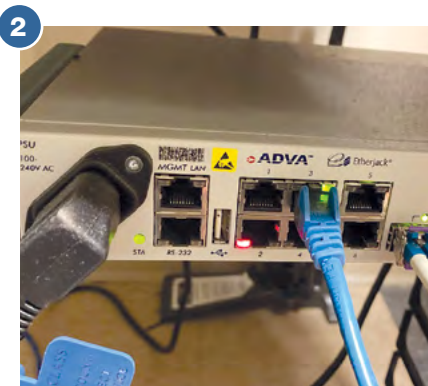
1. A ceiling-mounted WAP in an Elementary School classroom.
2. The Spectrum internet connection in the MTR.

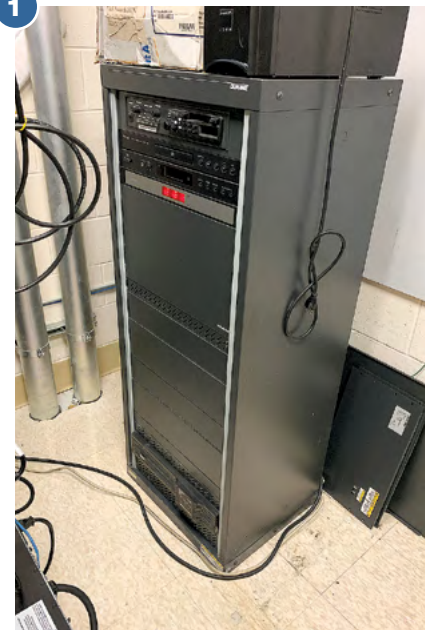
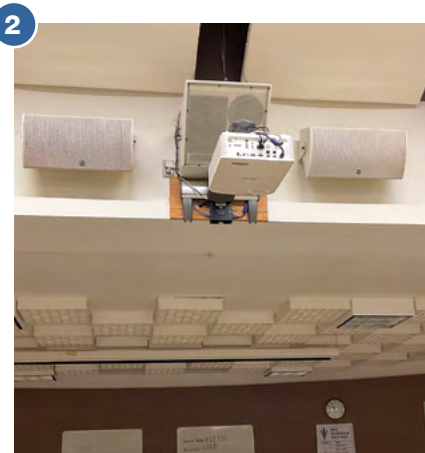
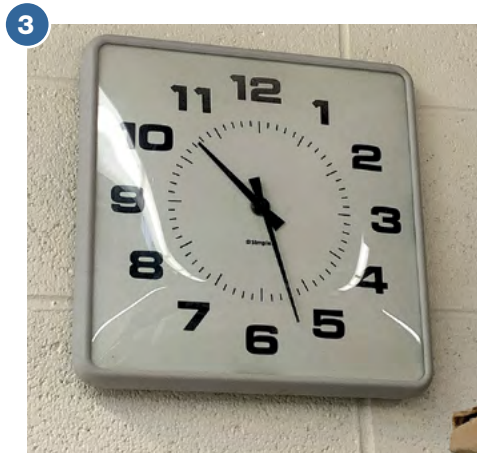
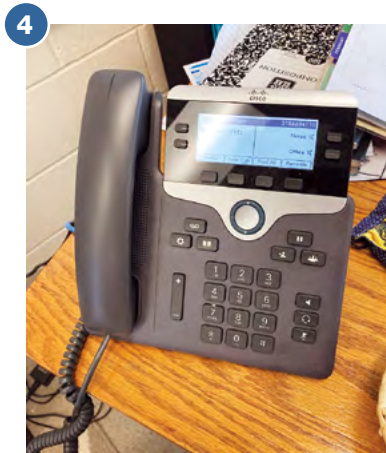
1. Outdated PA headend in the MTR.
2. A Large Group Instruction Audio-Enhancement system in the HS.
3. An analog clock in a High School corridor.
4. A Cisco VoIP handset on a teacher's desk.

- Replace building PA systems.
- Evaluate 911 call routing.
- Integrate lockdown messaging with Phone, PA and Security systems.
- Ensure all large assembly areas comply with ADA Listening Assist requirements.

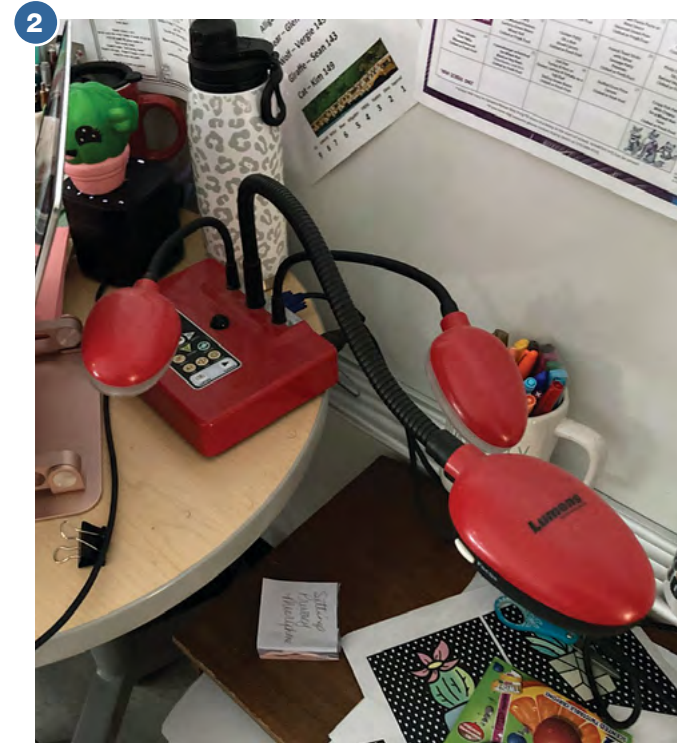
- Outdated SMARTboards (inset) have largely been upgraded to Interactive Flat Panels (IFPs) in the past few years.
- A typical HD document camera in an ES classroom.

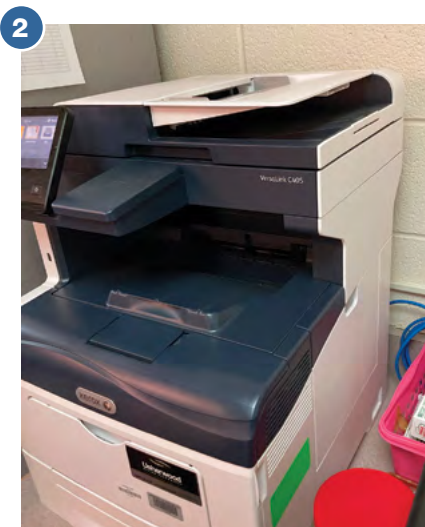
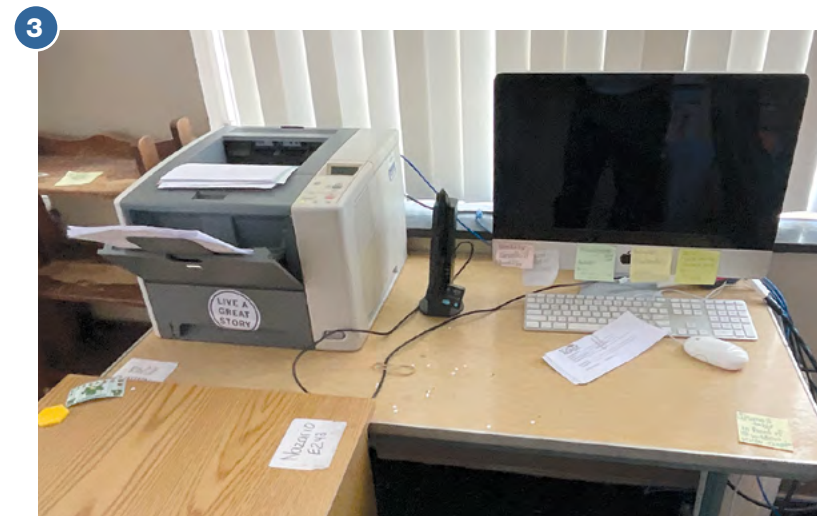
1. A teacher's classroom desktop in a classroom.
2. A typical classroom printer.
3. A newer iMac teacher desktop with a classroom laser printer.
